The Former  
**ST ANDREWS SUNDAY SCHOOL HALL**  
40 Rankin Avenue, New Lynn, Auckland

**PROPOSED REMEDIAL WORKS**  
required to make the building safe and secure

## Works Required to Make the Building Safe and Secure

14 December 2018

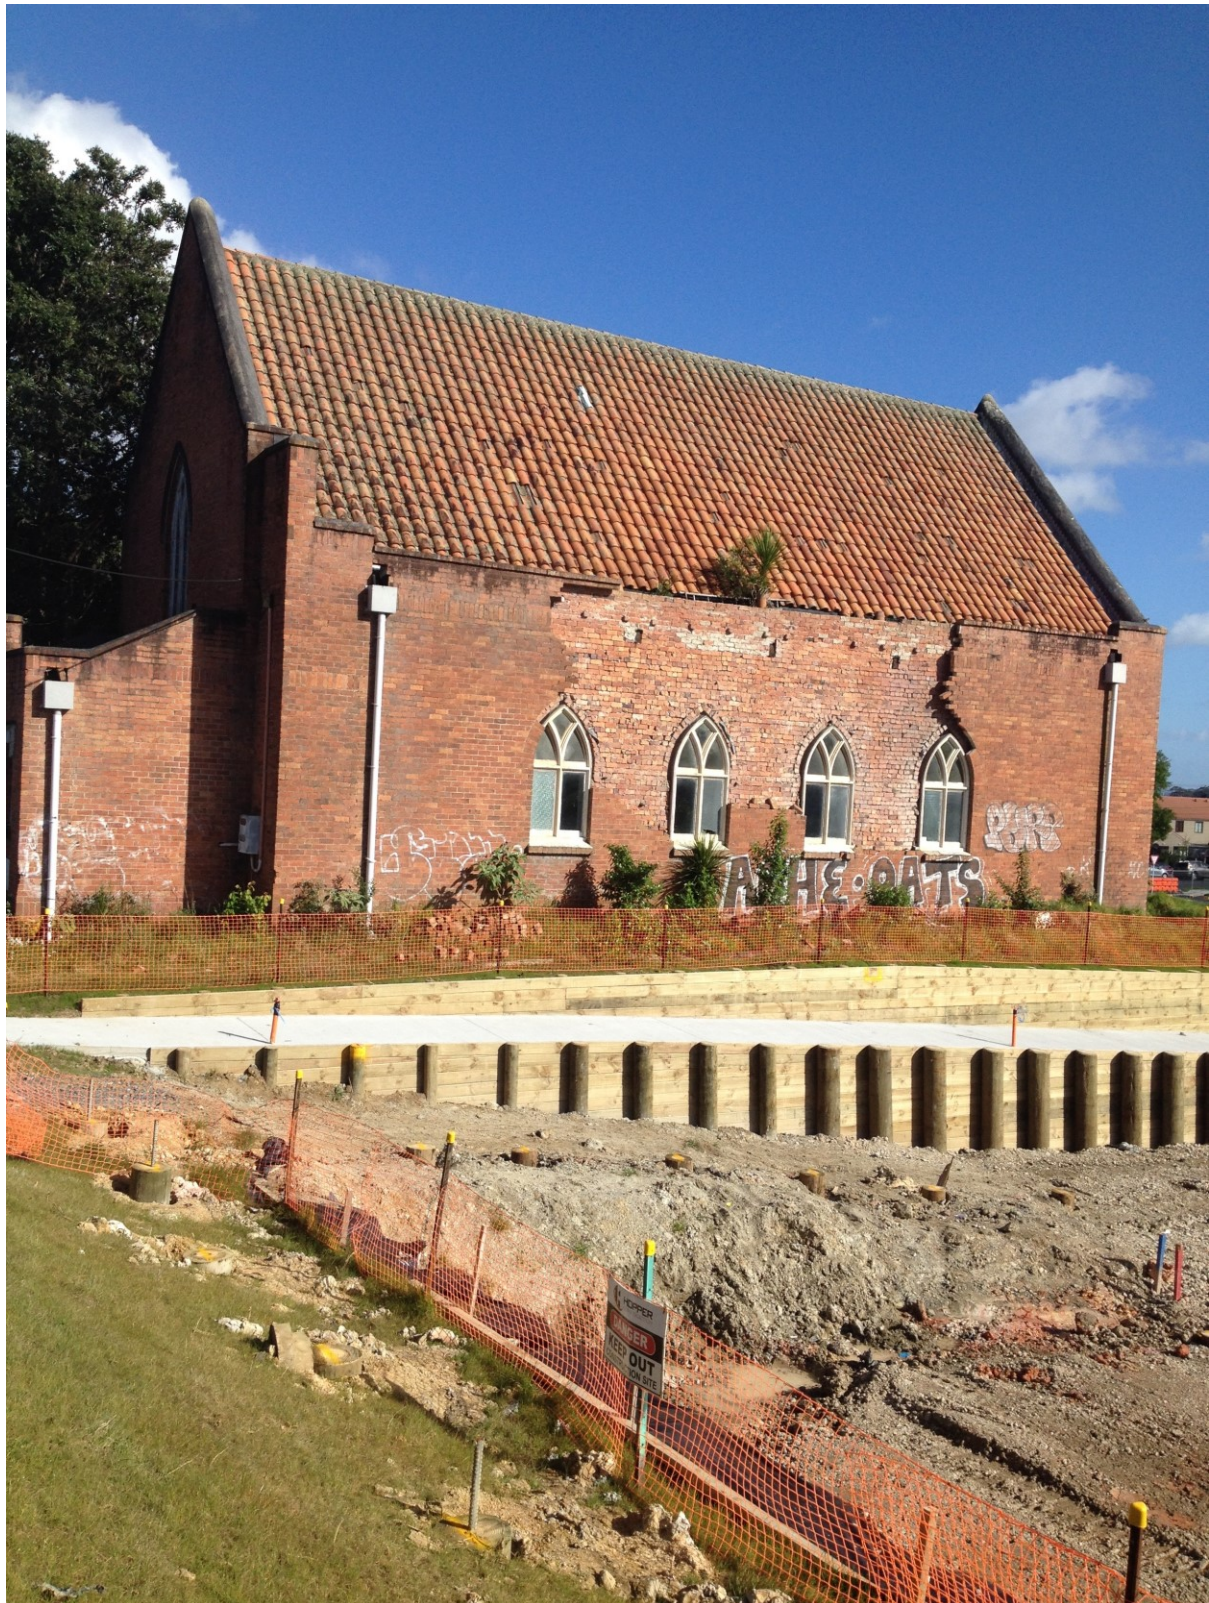
East elevation showing collapsed brickwork. Photograph: B,T&K Architects 2017

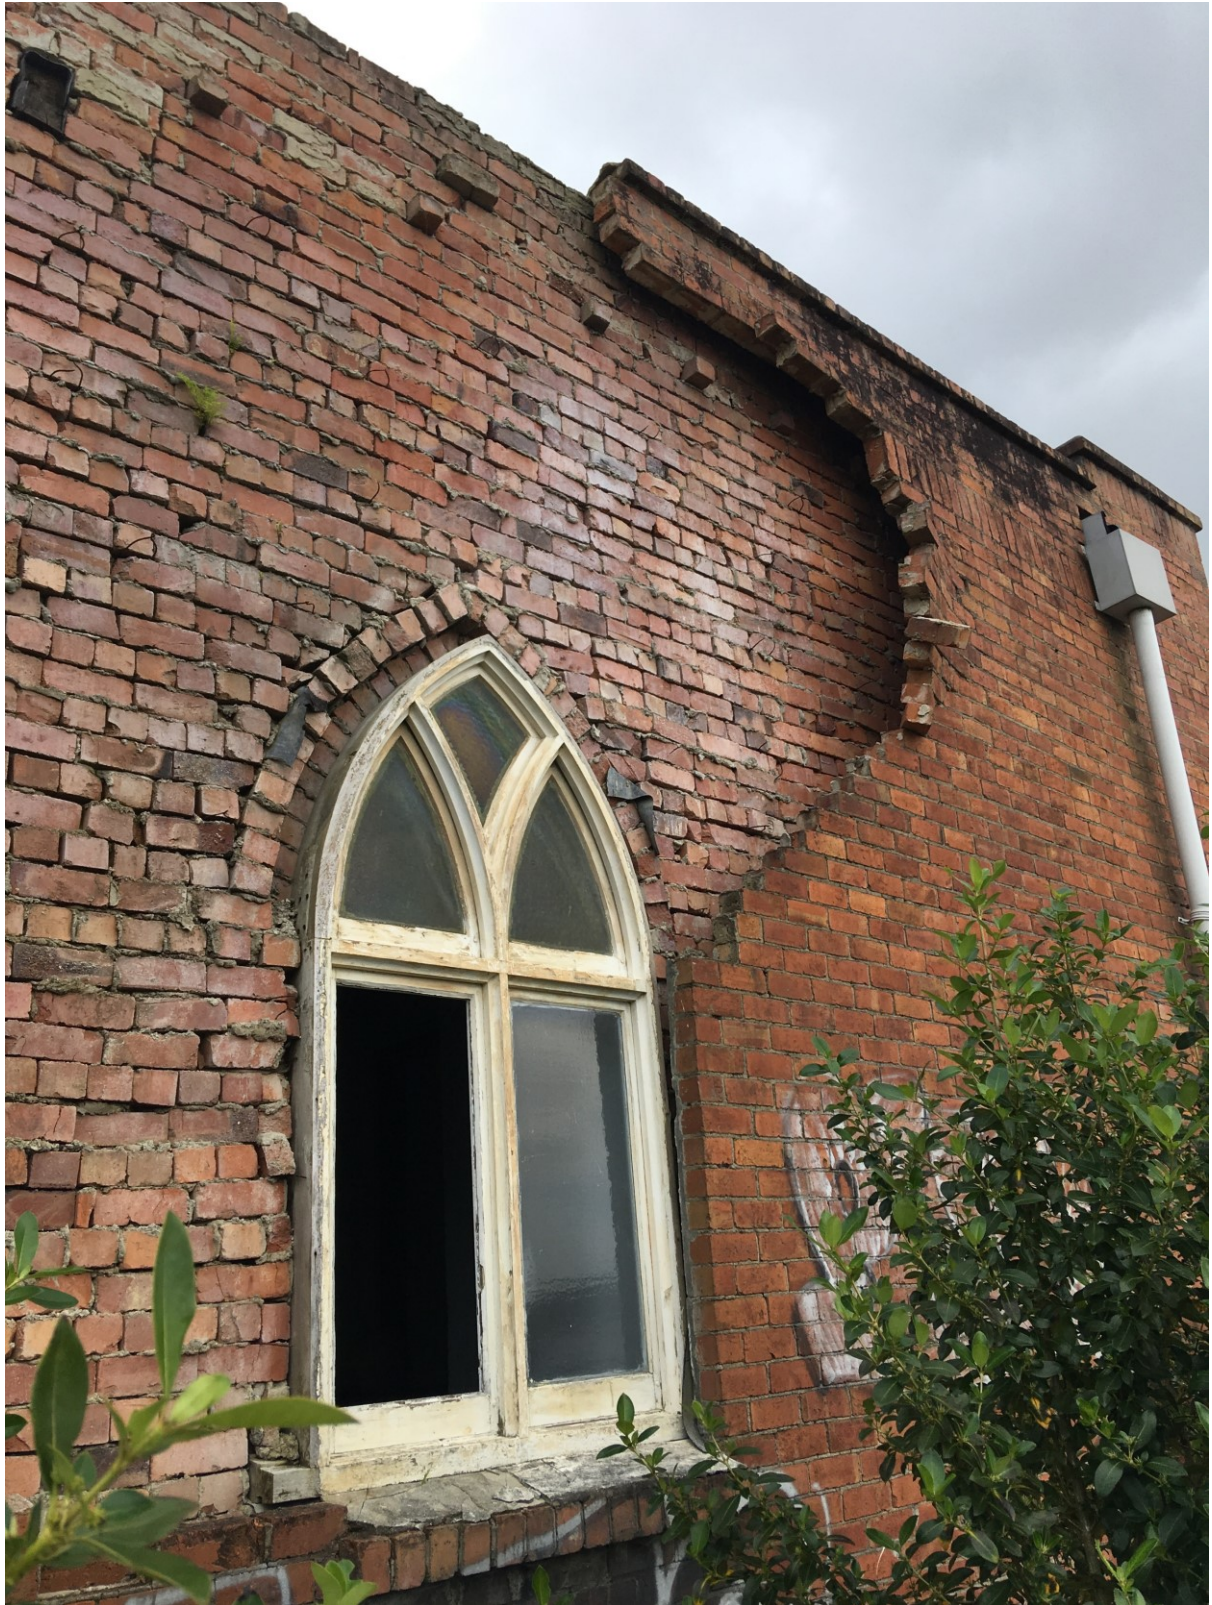
Showing further collapse of brickwork (August) along East wall. Photographs: B,T&K Architects 2018

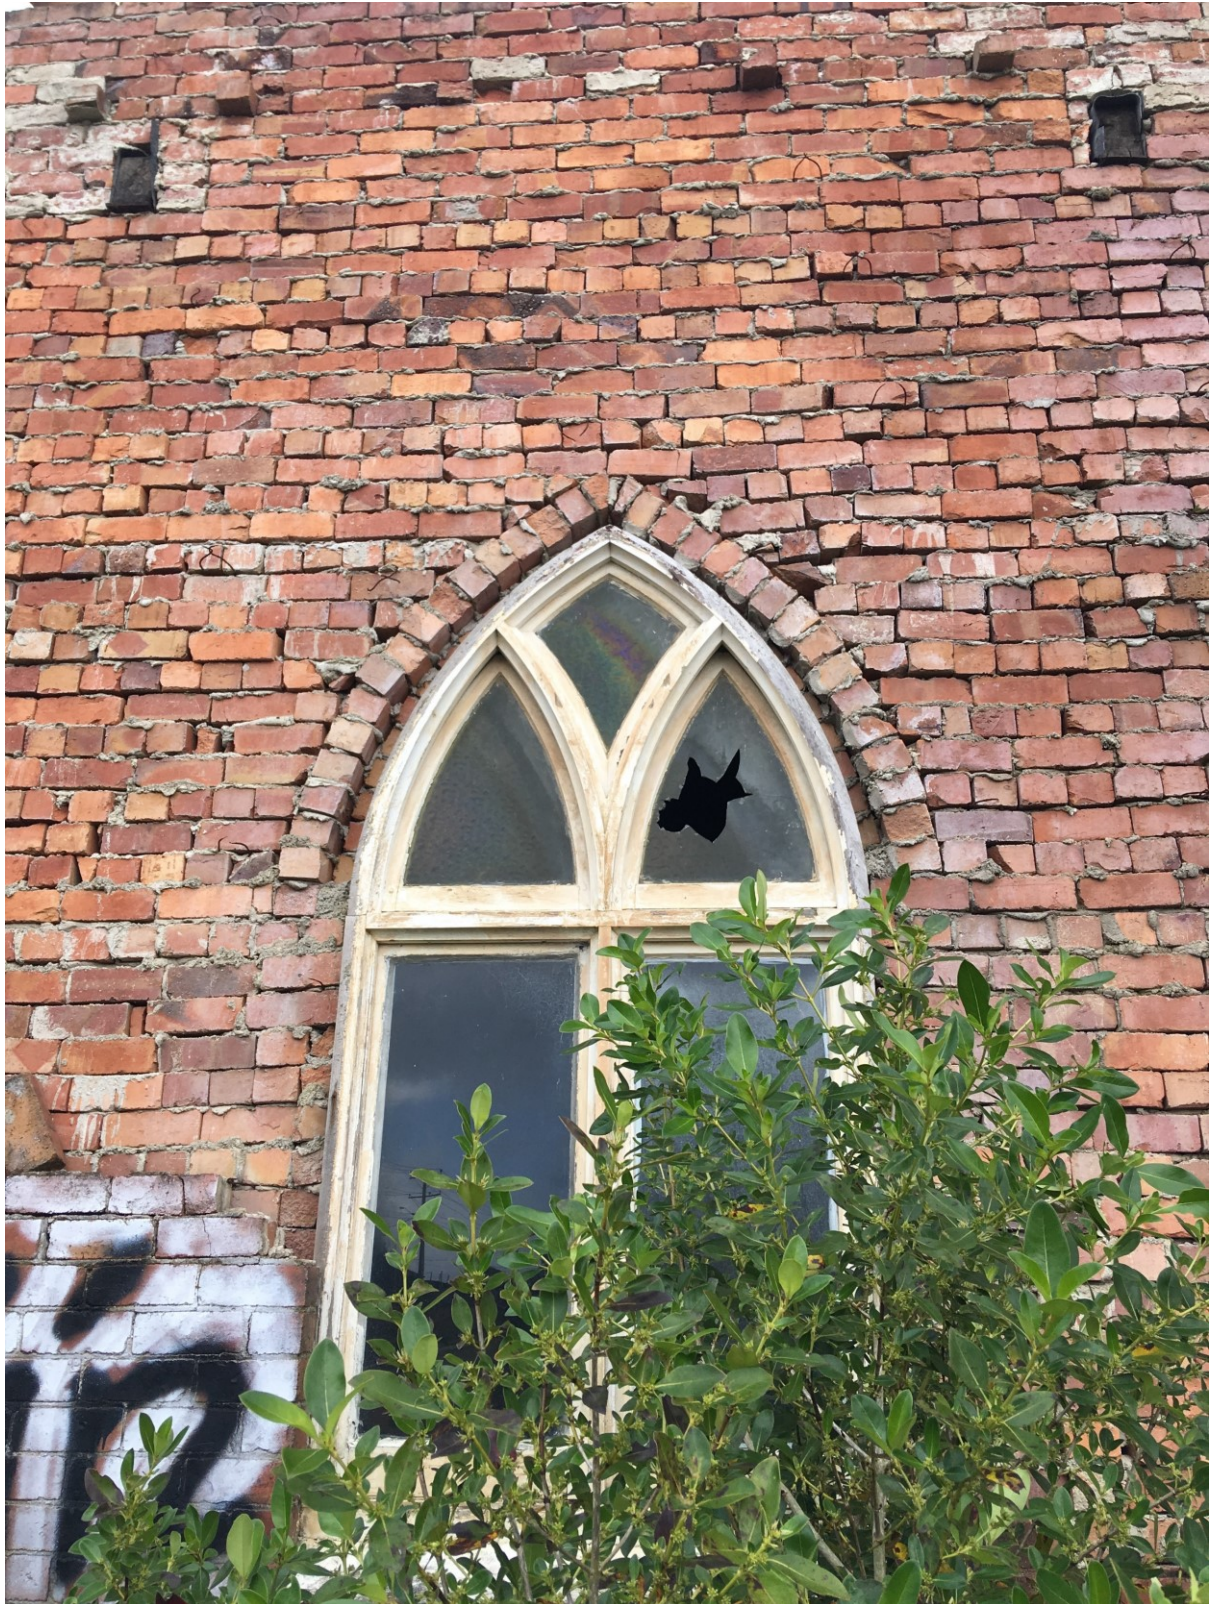
Broken glass in window and total collapse of outer skin of surrounding brickwork, East wall.  
Photograph: B,T&K Architects 2018

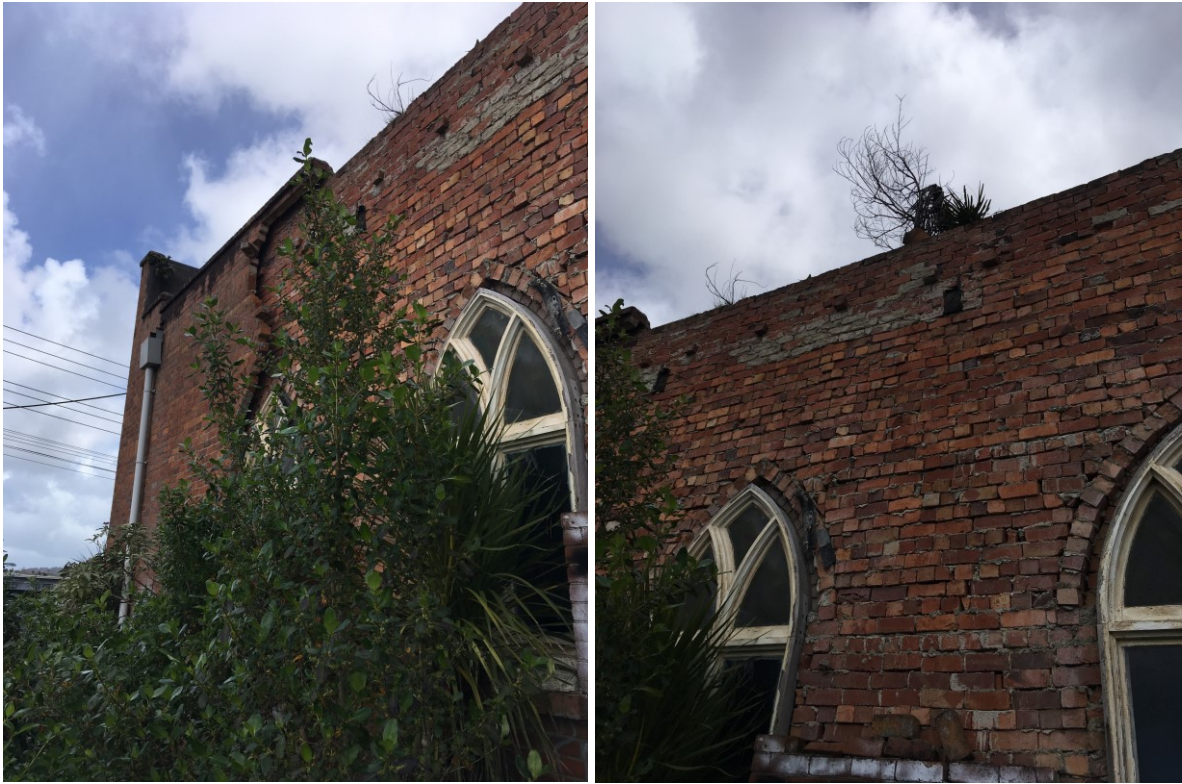
Showing significant collapse on East wall. Photographs: B,T&K Architects 2018

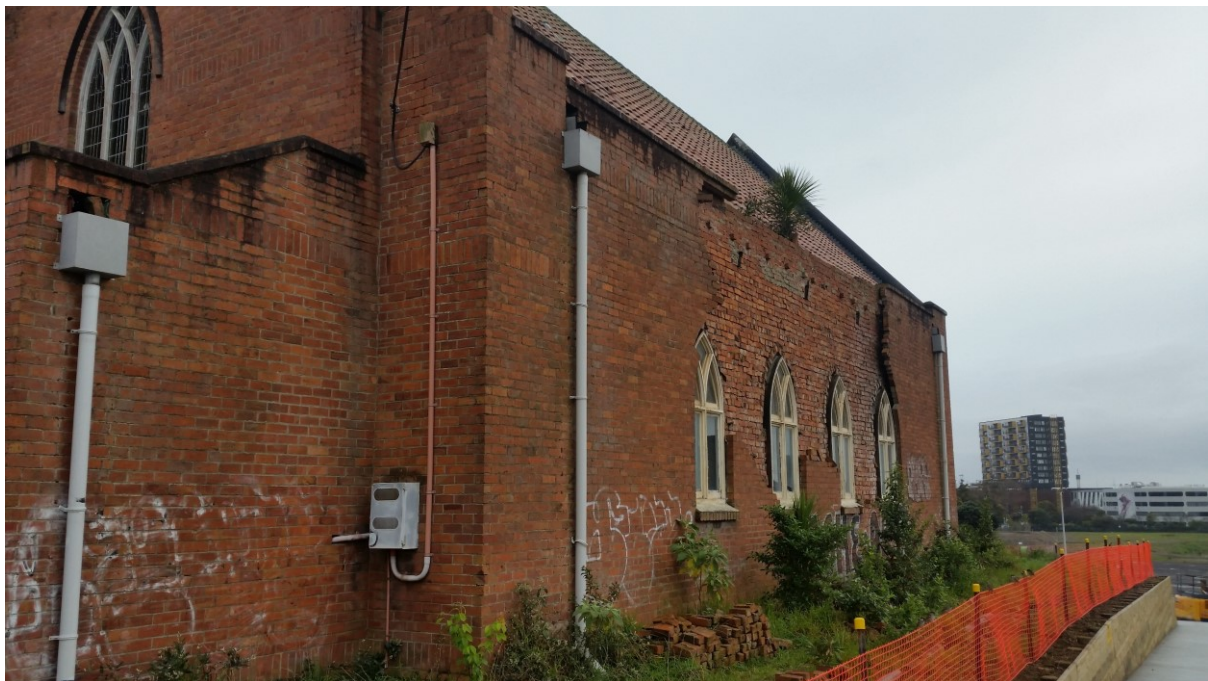
Showing damage to brickwork on eastern wall, as viewed from Margan Avenue. Photograph: B,T&K Architects 2017

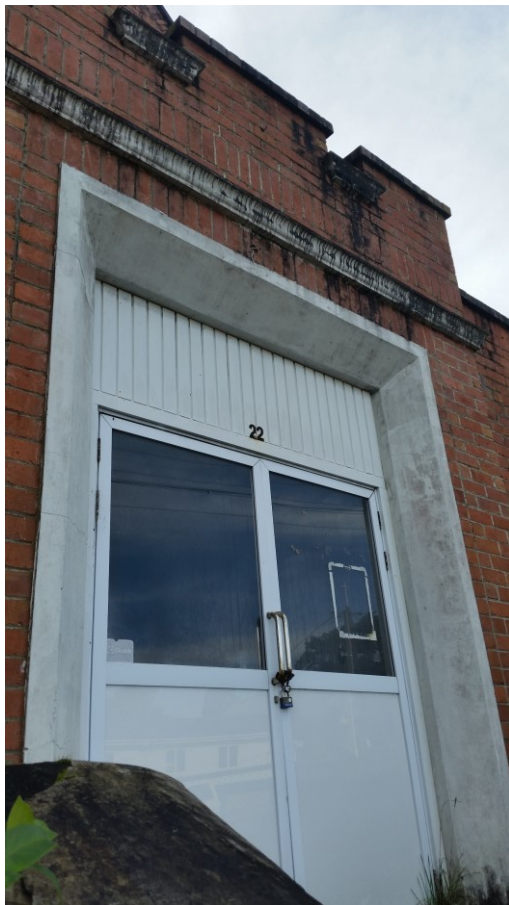
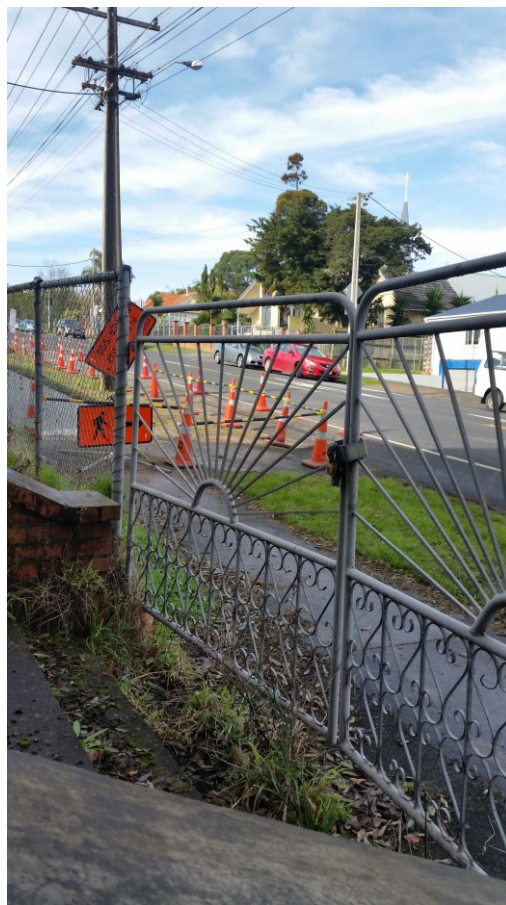
Main entry doors (dangerous building notice not displayed), left, gates to Margan Avenue, right. Photographs: B,T&K Architects

The doors at the front of the building are to be replaced with more substantial doors with a dead-lock, padlock and chain, to be used as access for building works.

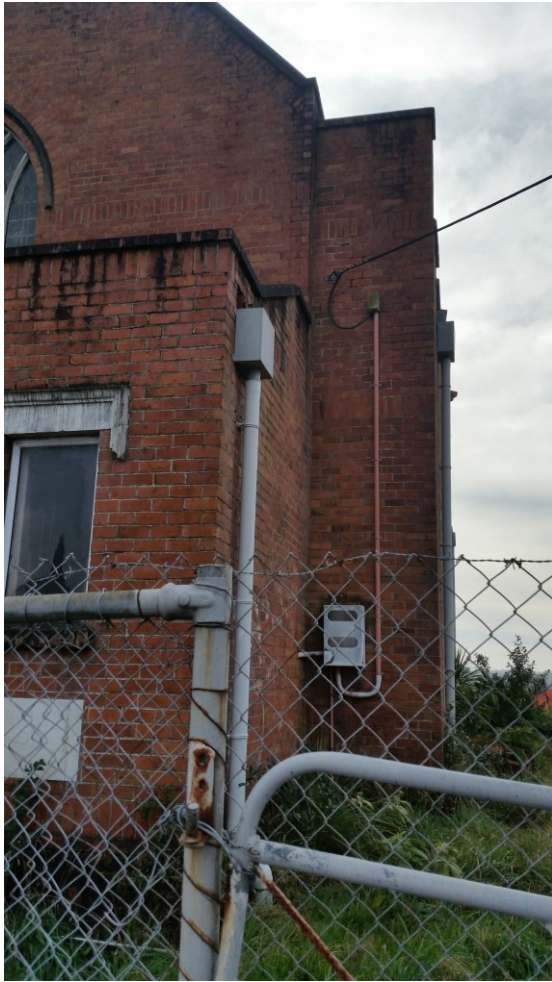
Mr van Zonnefeld confirmed that a 400 volt overhead supply is connected to the building, and that this aerial supply is live to the exterior meter board. The supply to the building from the meter board has been disconnected remotely by the supply authority. This is not considered safe given the condition of the building. Mr van Zonnefeld has recommended that the supply authority should be asked to de-energise that supply line.

Showing entry of overhead supply (400 volt) at south west corner (street elevation)  
Photographs: B,T&K Architects

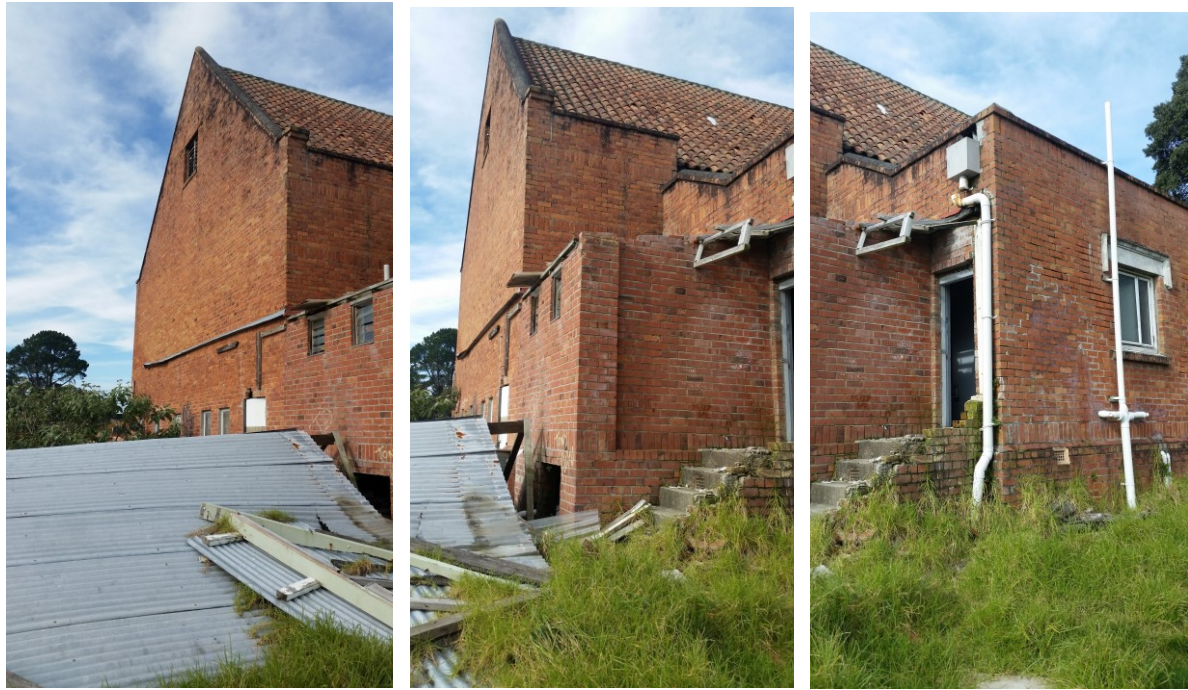
North west corner of the building, showing collapsed non-original toilet lean (to be demolished), and piles of building debris (to be removed from site). Photographs: B,T&K Architects

It is recommended that this addition is demolished and all openings blocked.

All the fallen down and damaged building material around the building needs to be cleared away. All the fallen bricks should be carefully stacked for possible re-use, and other material removed from the site.

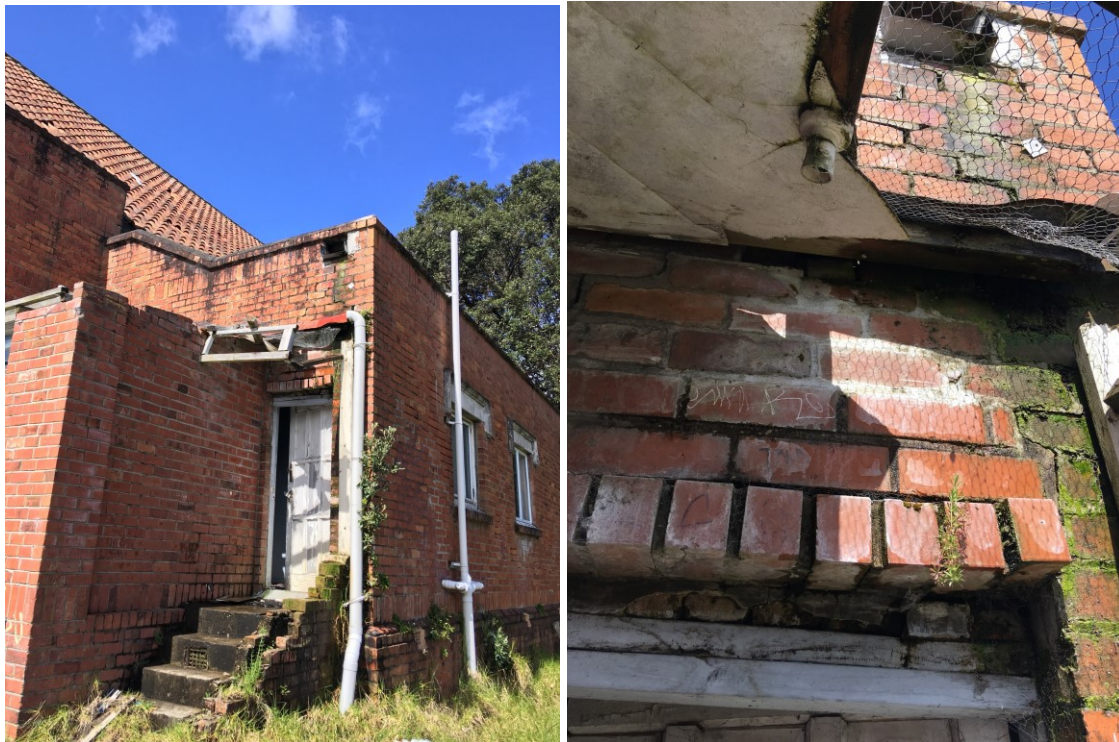
Showing rear unsecured entry on North elevation, left, collapsed lintel over doorway, right. Photographs: B,T&K Architects

The lintel over the rear entry door has failed. It is recommended that the opening is framed up in H3.2 timber to support the opening, and that the entry is closed with plywood cladding fitted to make it secure. (refer 3.3 Security).

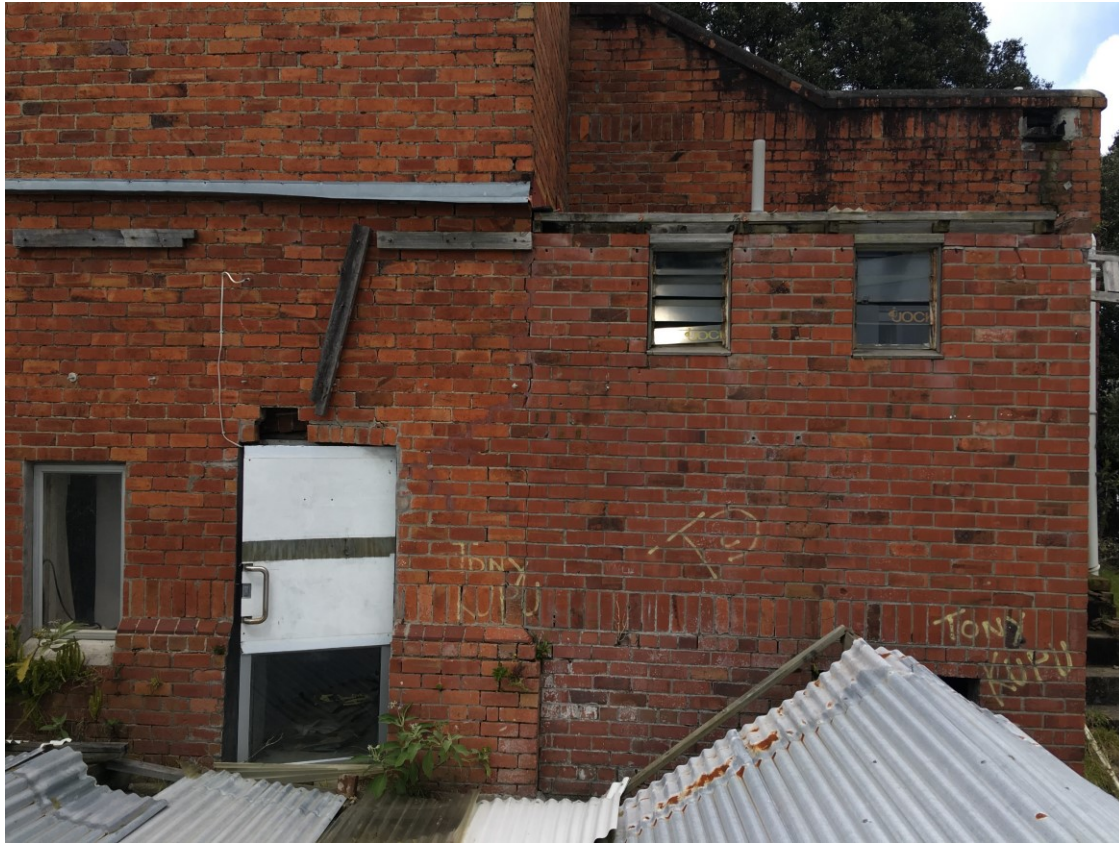
Showing unsecured door to basement + partially collapsed non-original toilet addition (to be demolished) on North elevation.

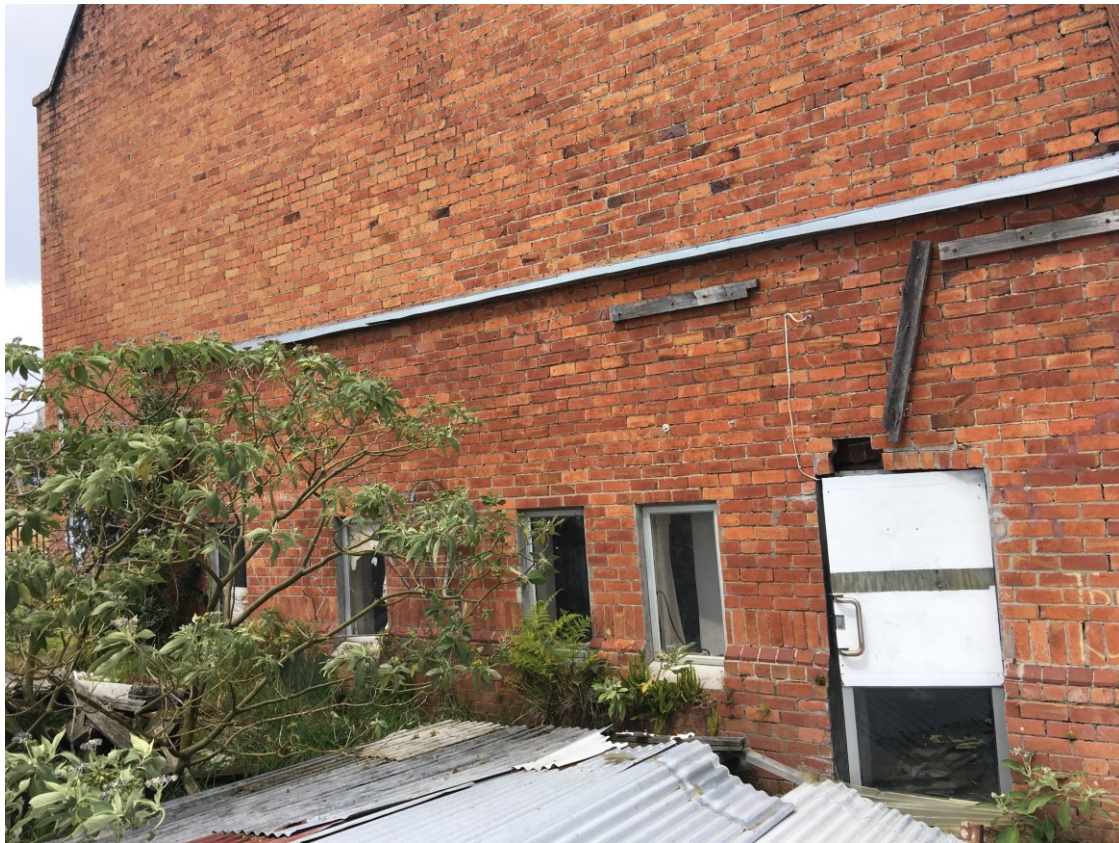
Unsecured openings to basement and loose building debris, South elevation. Photograph: B,T&K Architects 2018

To ensure that it is secure, all openings on the outside of the building that are open, ill fitting, or broken should be secured with full shuttering such as construction plywood. The shuttering should be framed and fixed without damage to brickwork or to existing original building fabric.

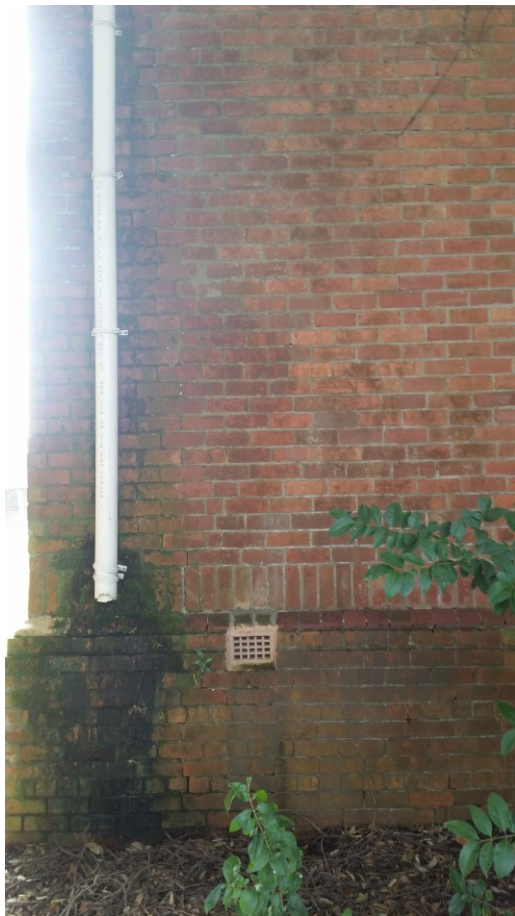
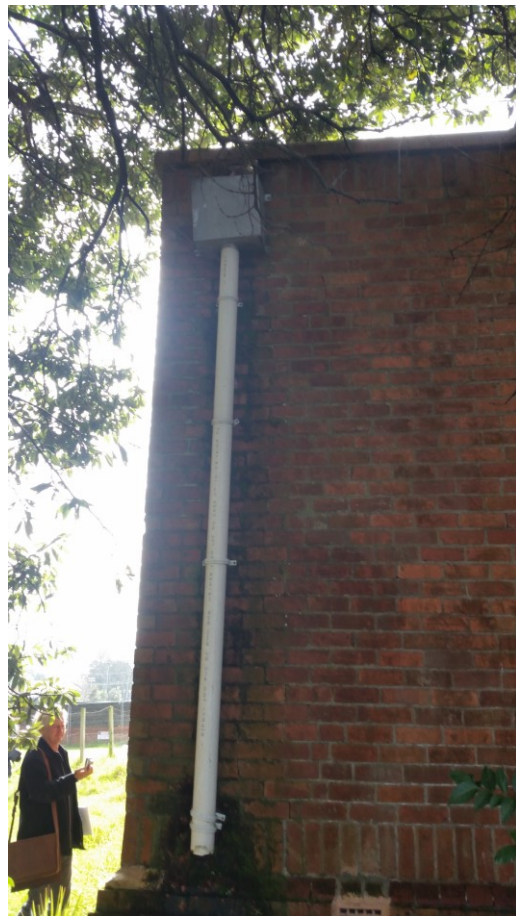
Down pipe disconnected and discharging directly on to side of building/ ground. Photographs: B,T&K Architects

He also recommended re-instating the fallen rain-water head at the north-west corner of the building, and replacing the other down-pipes where these are missing or damaged and re-connecting the down-pipes to the storm-water system.

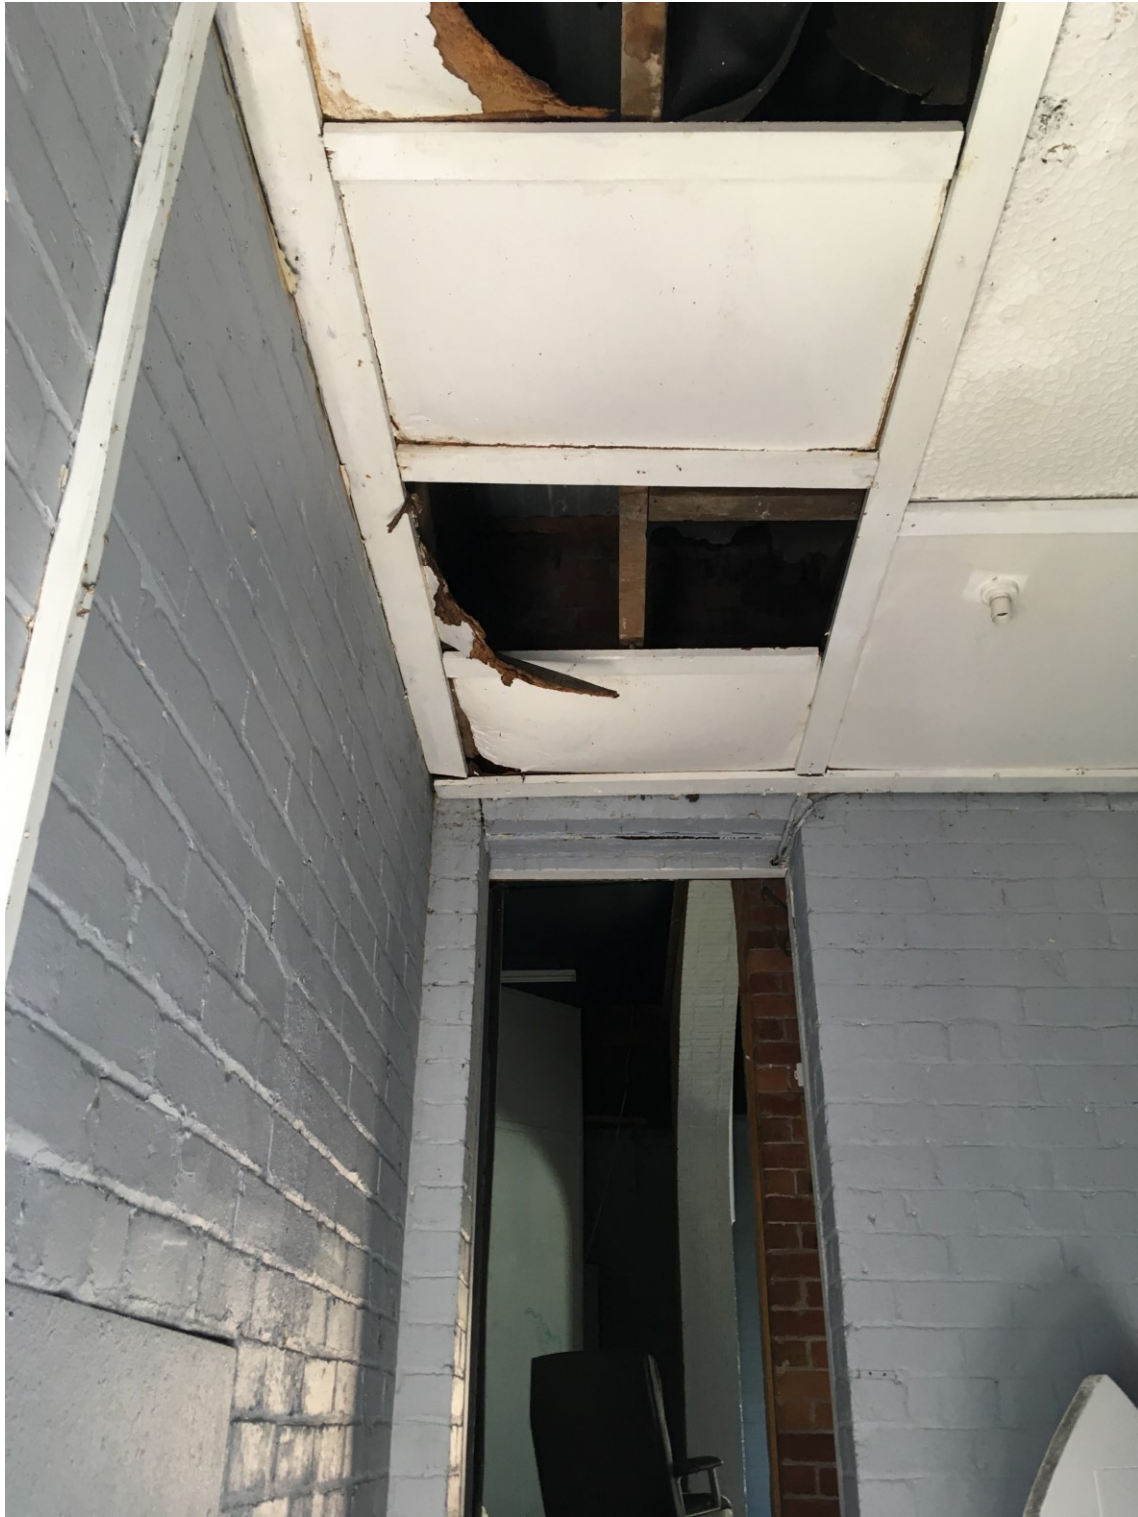
Damaged ceiling inside rear entry corridor. Photographs: B,T&K Architects 2018

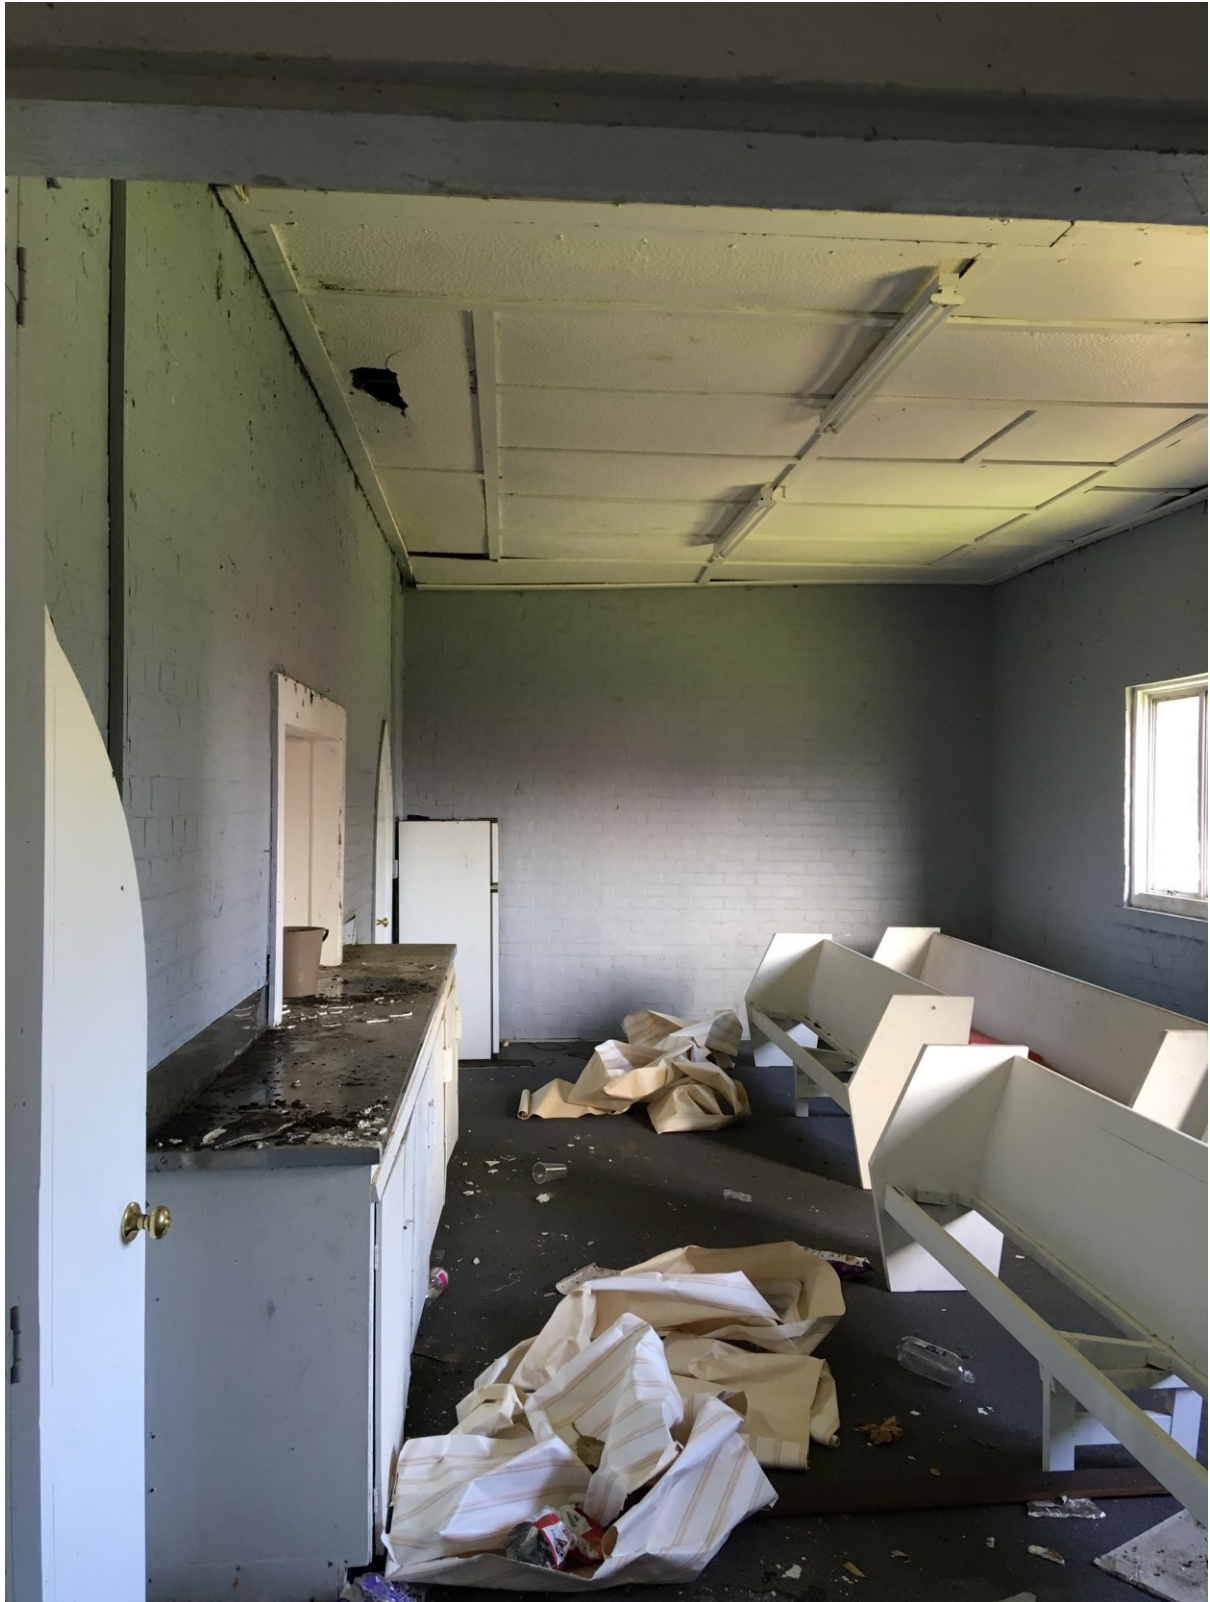
View of Classroom looking south, roof has been leaking causing water damage and collapse of ceiling in places. Photograph: B,T&K Architects 2018

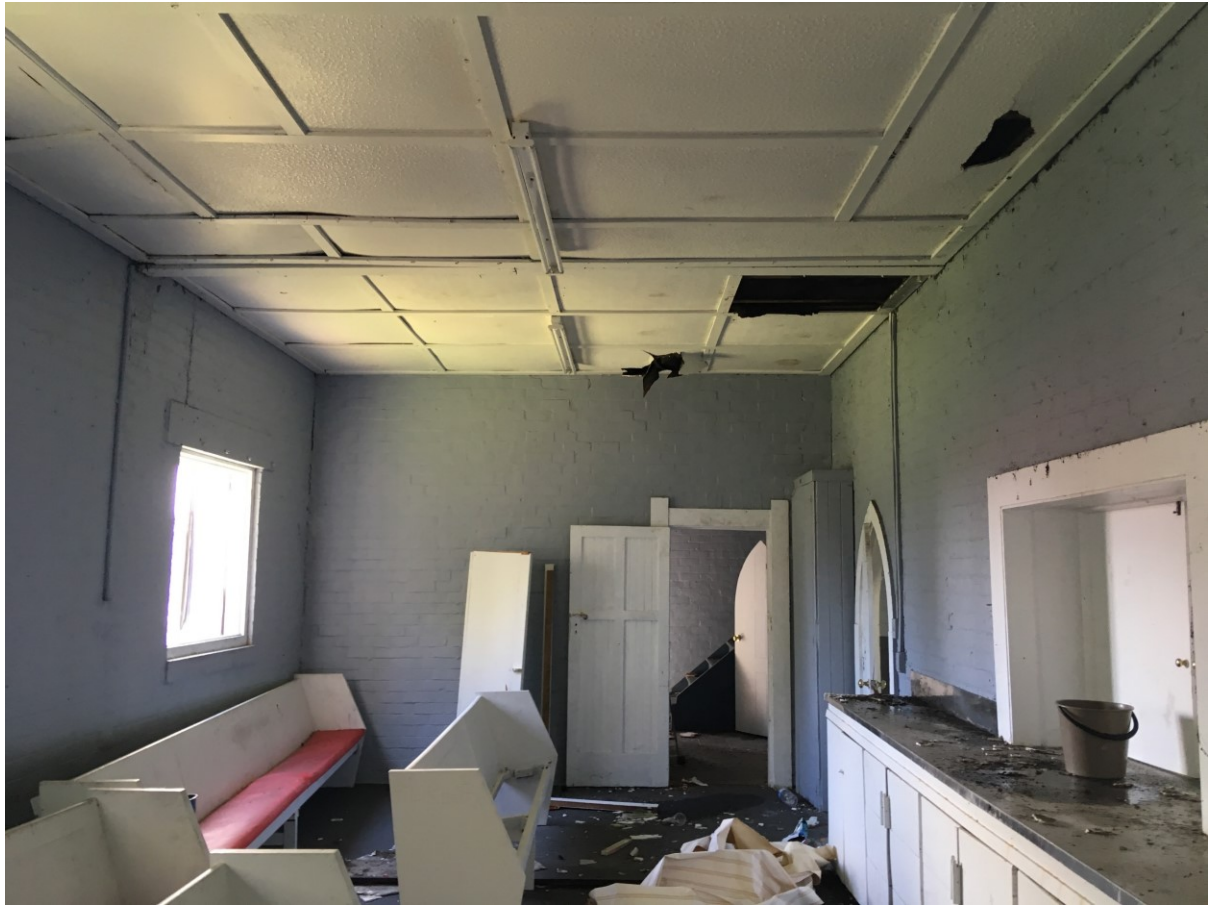
View of Classroom looking north, roof has been leaking causing water damage and collapse of ceiling in places. Photographs: B,T&K Architects 2018

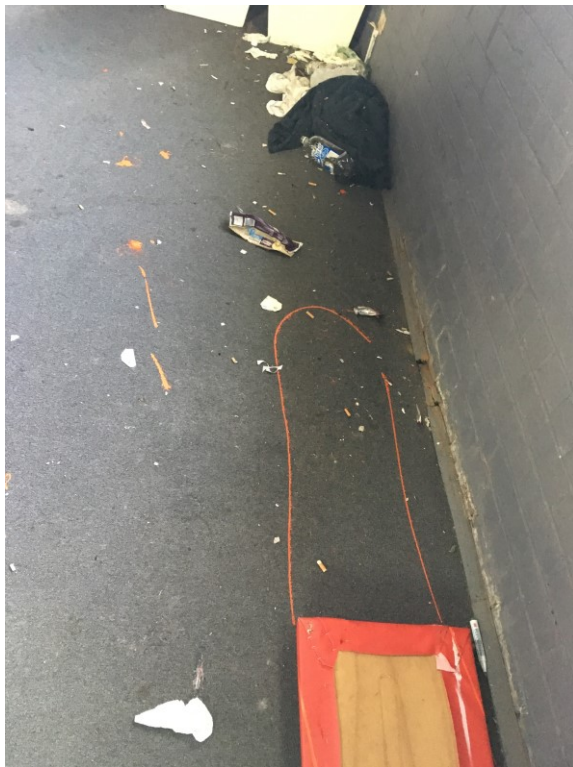
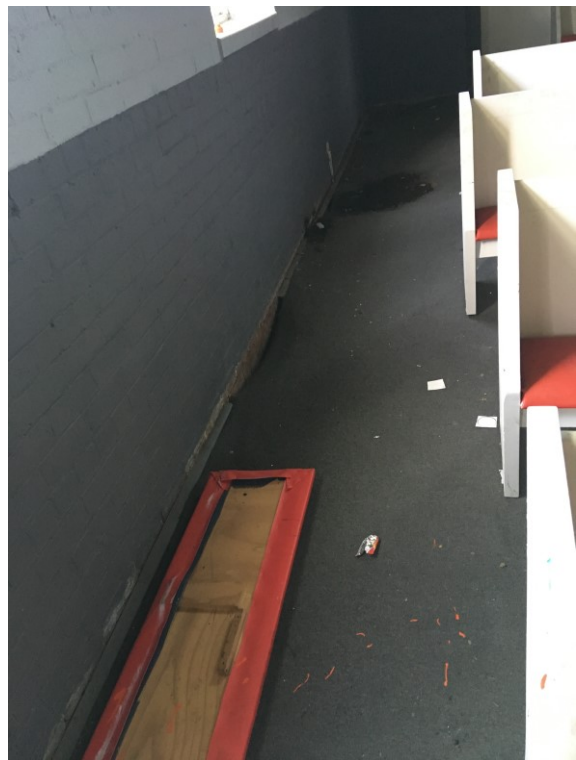
As a consequence of leaking since at least 2012, the floor and floor structure down the eastern side of the hall could be unreliable. The floor is carpeted. The carpet is sodden. It is highly probable that the timber in this area may be damaged. We did not walk on this section of the floor during our site visit.

Floor along eastern side of the hall, rotten and dangerous. Photographs: B,T&K Architects 2018

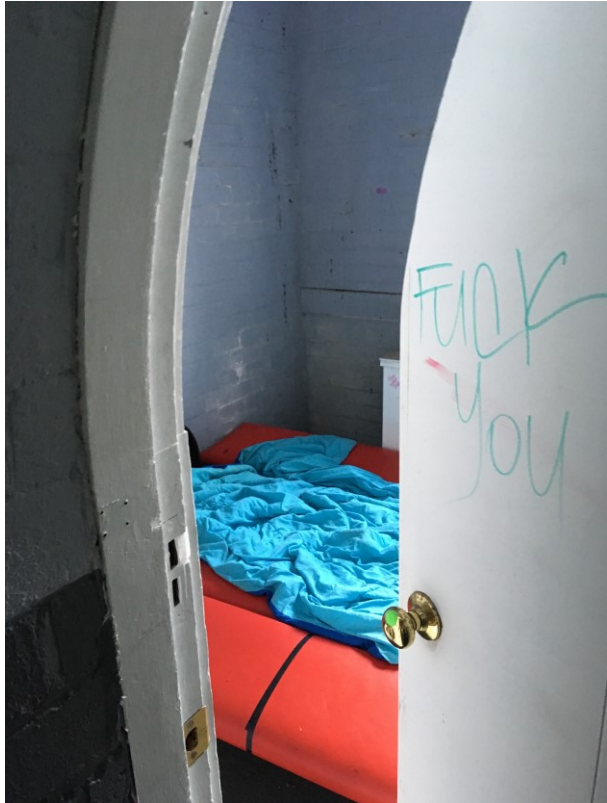
Evidence of vandalism and people sleeping rough in the building. Photograph: B,T&K Architects 2018

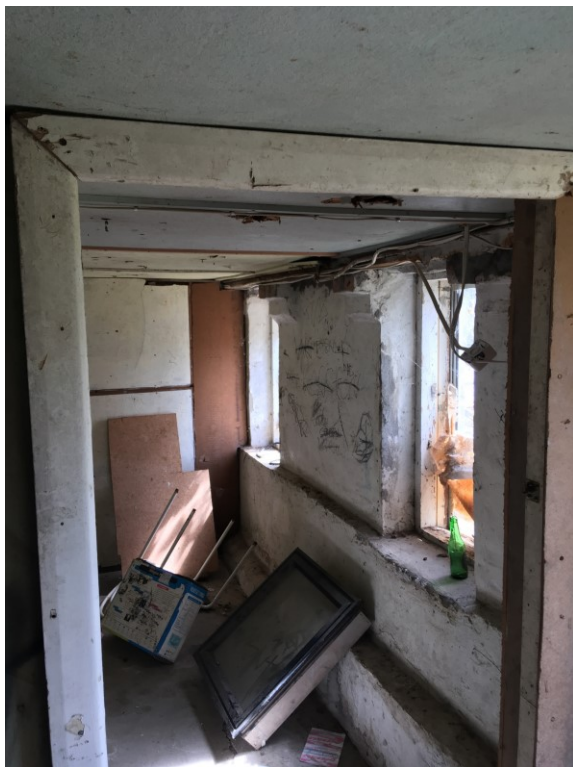
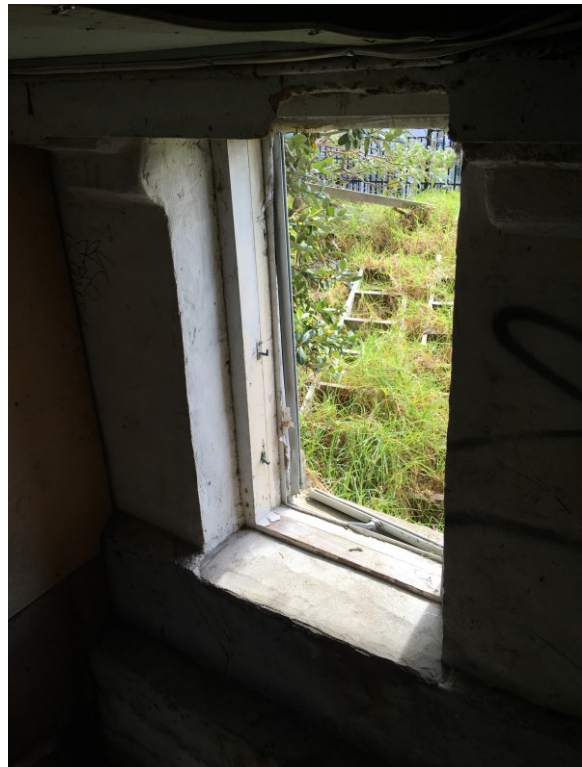
Unsecured windows in basement, north elevation. Photograph: B,T&K Architects 2018
